**Flood Control Project Maintenance
Levee Inspections**
LMA District Cover Sheet
Spring 2017 Levee Inspection Results

Reclamation District No. 0537 Lovdal

Spring 2017 Levee Inspection Results

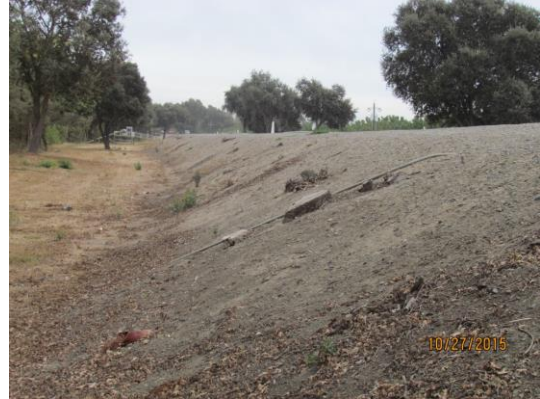
Photo 1 of 1 : SP_2017_RD0537_173_22_20170320_00020.jpg

View of the tree stumps on the waterward side of the levee looking downstream. Fall 2015.

LM Start	0.05	Rating **	U	Issue No.	476
LM End	0.05	Issue Type +	En	Location *	WS
Category	Supplemental			GPS Latitude/Longitude	
				Start	End
Item	DWR UCIP Field Study			38.643400 °	38.643400 °
				-121.583380 °	-121.583380 °
DWR ID

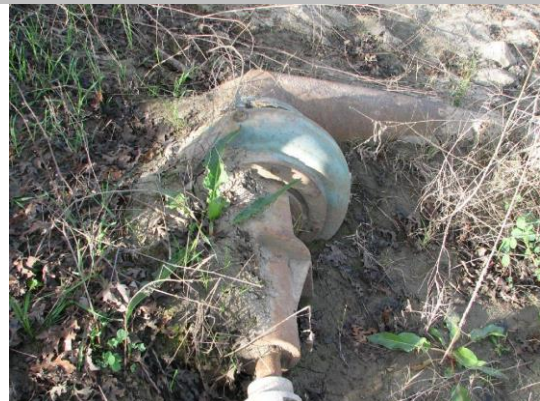
Photo 1 of 3 : UCIP_SP_2017_50087_17140.jpg

Comment Code					
Inspector Comment					
FS_ID:50087 DS_ID:169 EP_NO: 558 Repair Type: Urgent Crossing Status: Found UCIP Comments: 07/18/2016 - Same as last inspection. Pipe severely corroded. Since it is a deep irrigation pipe, cracking on pavement likely not caused by pipe. (K. Fazel/UCIP)03/18/2013 - Crossing appears abandoned; if so, must be done so properly. Cracking on pavement along pipe alignment. Holes visible on pipe along WS slope. (P. Amatya/UCIP) FIELD_STRUCT_DESC: *ABANDONED* 10-inch steel irrigation pipe through the levee, 18 feet below the crown. Centrifugal pump on the waterside (WS). Concrete collar on the WS per permit drawing, not found in 2016. Polyvinyl chloride (PVC) standpipe and valve enclosed by concrete standpipe off landside (LS) toe, likely not associated with the crossing, per Ken Lang of RD0537. 1-inch electric conduit through the levee, 3.8 ft below the crown (this may not be associated with the crossing, per Ken Lang). (Permit No. 558, 1932 - Marty Brothers). Current adjacent landowner is Giovennetti Ranch but pipe is not used by landowner. [Additional Reference(s): DWR Levee Log, 2004 (HLM 0.04)]. Permit drawing (issued in 1932) indicates pipe depth is 6.7 ft, however permit was issued prior to the construction of a new levee prism above the old levee in 1955. FS Date: 7/18/2016

WS- an abandoned pump.

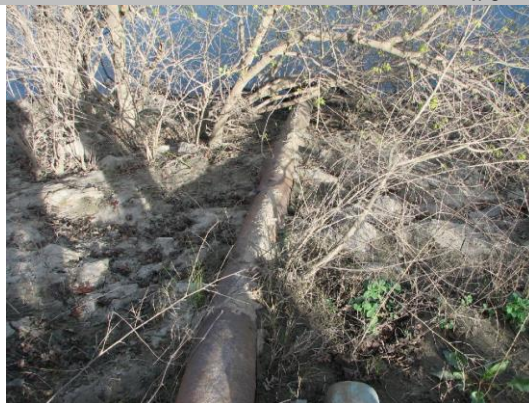
Photo 2 of 3 : UCIP_SP_2017_50087_17141.jpg

WS- abandoned steel pipe.

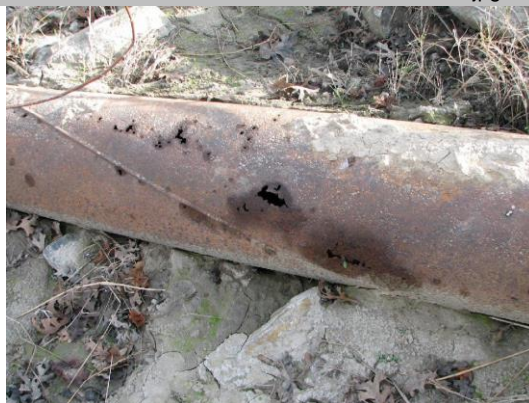
Photo 3 of 3 : UCIP_SP_2017_50087_17142.jpg

WS- visible holes on the pipe.

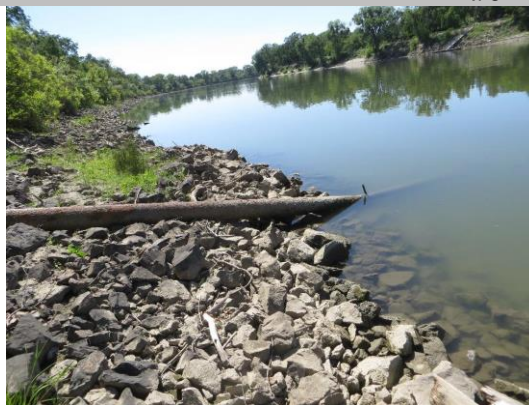
Photo 2 of 3 : UCIP_SP_2017_46803_74403.jpg

LM Start	0.07	Rating **	M	Issue No.	477
LM End	0.07	Issue Type +	En	Location *	WS
Category	Supplemental			GPS Latitude/Longitude	
				Start	End
Item	DWR UCIP Field Study			38.643528 °	38.643528 °
				-121.583193 °	-121.583193 °
DWR ID					
Comment Code					
Inspector Comment					
FS_ID:46803 DS_ID:168 EP_NO: N/A Repair Type: Non-Urgent Crossing Status: Found UCIP Comments: Crossing appears abandoned; if so, must be done so properly. FIELD_STRUCT_DESC: *ABANDONED* 10-inch steel irrigation pipe, 3.8 FBC. Pump gone. Concrete pump pad on WS bank not found. 36-inch concrete standpipe off LS toe. 2-inch electric conduit not found (1-inch electric line found for 10-inch pipe located 50 ft upstream). Plate bolted on WW end of pipe. FPIIB 2004 Levee Logs. FS Date: 4/29/2015

View of pipe into water.

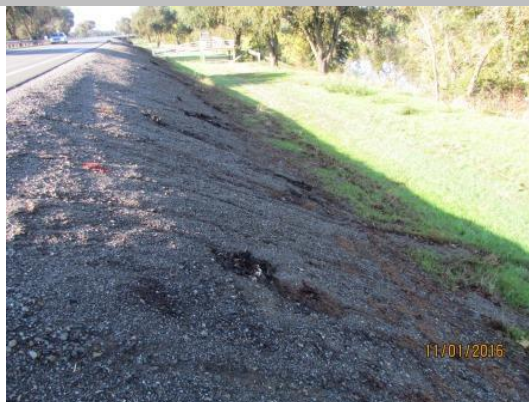
Photo 1 of 1 : SP_2017_RD0537_173_34_20170320_00030.jpg

LM Start	0.18	Rating **	M	Issue No.	34
LM End	0.23	Issue Type +	Ma	Location *	WS
Category	Earthen Levee			GPS Latitude/Longitude	
				Start	End
Item	Erosion / Bank Caving			38.644628 °	38.645083 °
				-121.581589 °	-121.580843 °
DWR ID	DWR_RD0537_01_f_2016_34				
Comment Code					
E2 : Schedule repair of erosion site prior to the next inspection.					
Inspector Comment

Runoff erosion on waterside slope. Fall 2016.

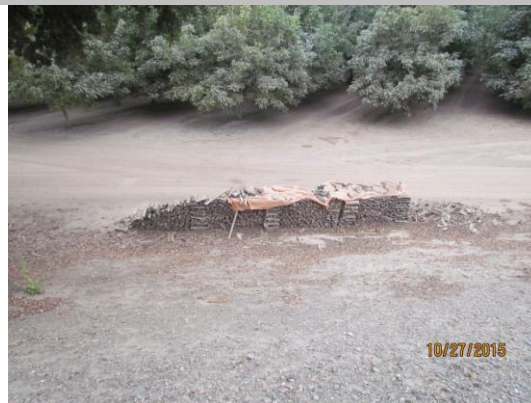
Photo 1 of 3 : SP_2017_RD0537_173_47_20170320_00047.jpg

View of the firewood pile at the toe of the levee on the landward side. Fall 2015.

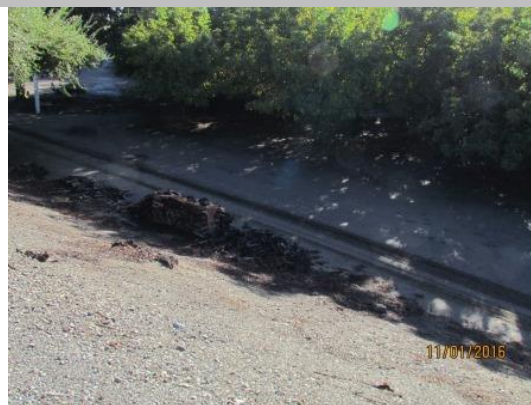
Photo 2 of 3 : SP_2017_RD0537_173_47_20170320_00048.jpg

Updated view of firewood at LS toe. Fall 2016.

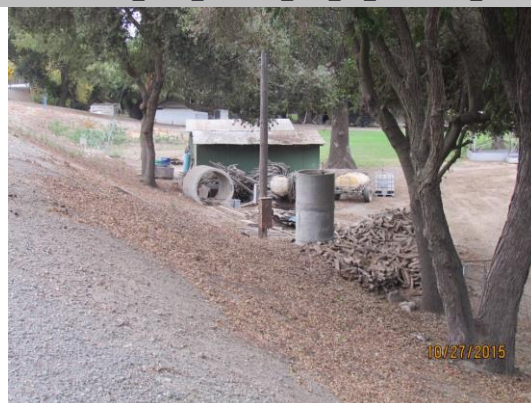
Photo 3 of 3 : SP_2017_RD0537_173_47_20170320_00049.jpg

Perspective view of more firewood at the toe of the levee on the landward side looking downstream. Fall 2015.

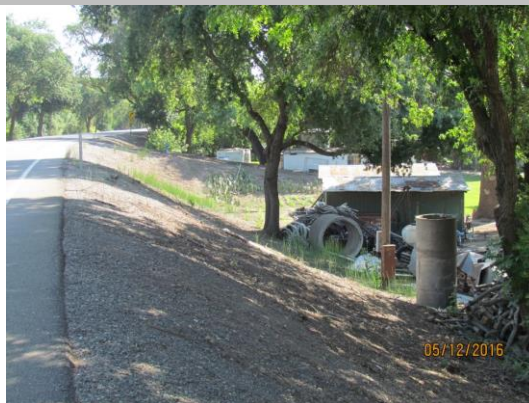
Photo 1 of 2 : SP_2017_RD0537_173_6_20170320_00003.jpg

View of the equipment at the toe of the levee looking downstream. Spring 2016.

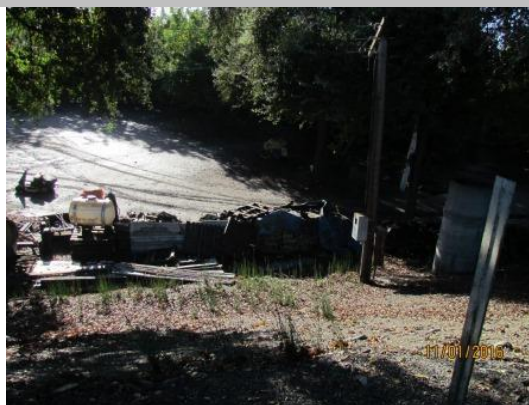
Photo 2 of 2 : SP_2017_RD0537_173_6_20170320_00004.jpg

Updated view of equipment at landside toe. Fall 2016.

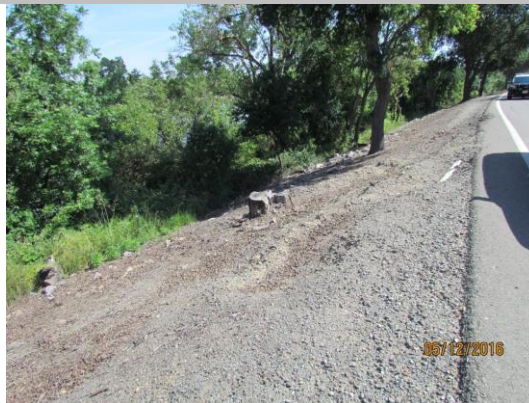
Photo 1 of 1 : SP_2017_RD0537_173_31_20170320_00027.jpg

LM Start	0.42	Rating **	M	Issue No.	31
LM End	0.42	Issue Type +	Ma	Location *	WS
Category	Earthen Levee			GPS Latitude/Longitude	
				Start	End
Item	Slope Stability			38.646811 °	38.646811 °
				-121.578241 °	-121.578241 °
DWR ID	DWR_RD0537_01_s_2016_31				
Comment Code					
S3 : Repair the levee slope damaged by vehicle traffic and prevent access where possible.					
Inspector Comment

View of the slope stability near the shoulder of the waterward side of the levee looking downstream. Spring 2016.

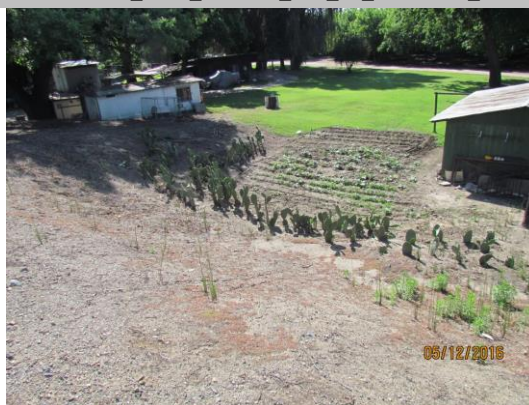
Photo 1 of 2 : SP_2017_RD0537_173_18_20170320_00017.jpg

View of the cactus at the toe of the levee. Spring 2016.

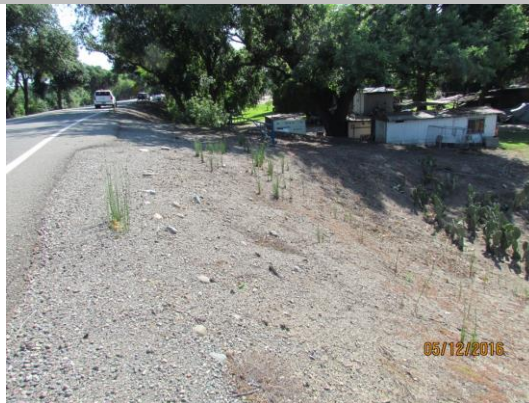
Photo 2 of 2 : SP_2017_RD0537_173_18_20170320_00018.jpg

Perspective view of the landscaping on the landward side of the levee looking downstream. Spring 2016.

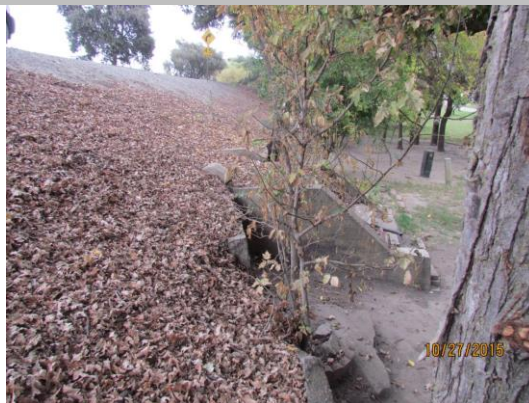
Photo 1 of 3 : SP_2017_RD0537_173_50_20170320_00052.jpg

View of the retaining wall at the levee toe on the landward side of the levee looking downstream. The wall is partially broken. Fall 2015.

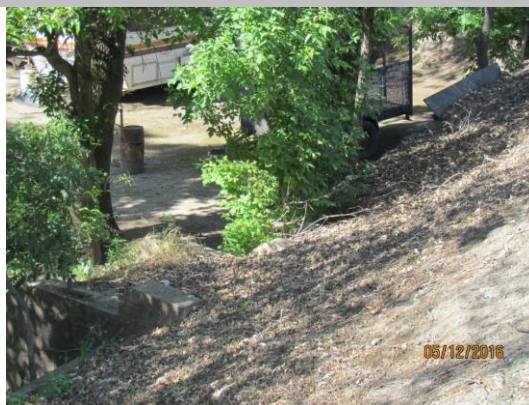
Photo 2 of 3 : SP_2017_RD0537_173_50_20170320_00053.jpg

View of the retaining wall at the toe of the levee on the landward side. Spring 2016.

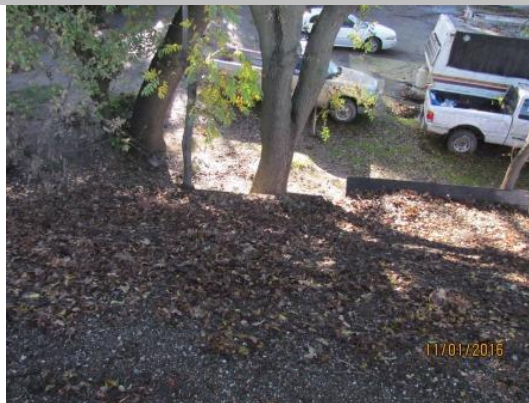
Photo 3 of 3 : SP_2017_RD0537_173_50_20170320_00054.jpg

Updated view of the site. Fall 2016.

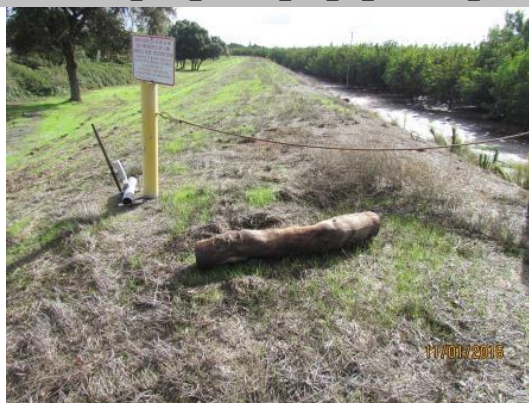
Photo 1 of 1 : SP_2017_RD0537_173_54_20170320_00058.jpg

Debris on levee crown near the gate. Fall 2016.

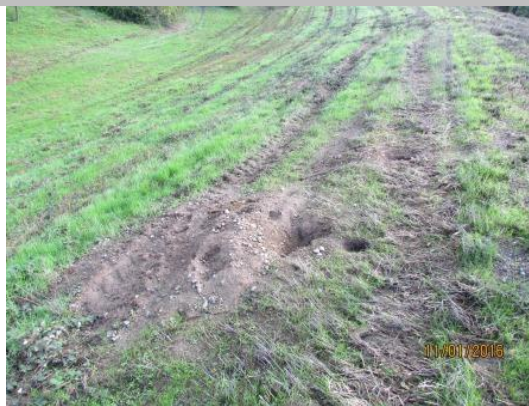
Photo 1 of 1 : SP_2017_RD0537_173_51_20170320_00055.jpg

View of animal burrows on WS slope with large amount of soil out. Fall 2016.

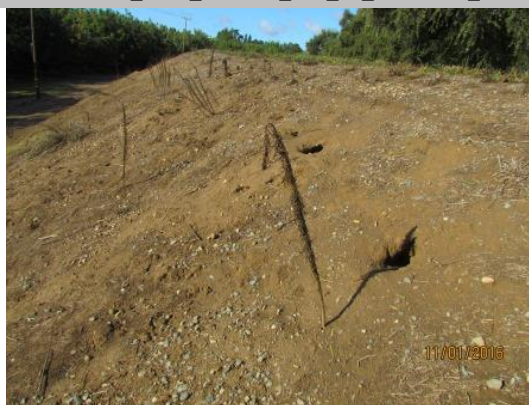
Photo 1 of 1 : SP_2017_RD0537_173_48_20170320_00050.jpg

Animal burrows on LS slope. Fall 2016.

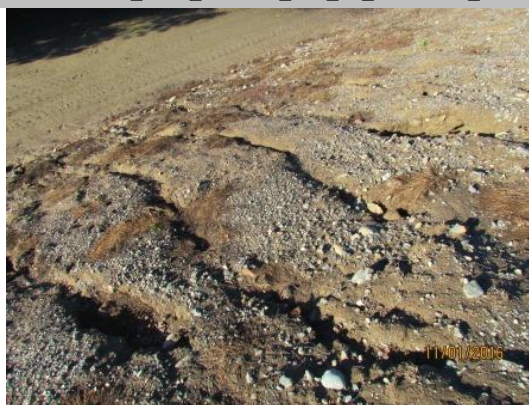
Photo 1 of 3 : SP_2017_RD0537_173_35_20170320_00031.jpg

LM Start	0.81	Rating **	U	Issue No.	35
LM End	0.81	Issue Type +	Ma	Location *	LS
Category	Earthen Levee			GPS Latitude/Longitude	
				Start	End
Item	Erosion / Bank Caving			38.647181 °	38.647181 °
				-121.571586 °	-121.571586 °
DWR ID	DWR_RD0537_01_f_2016_35				
Comment Code					
E2 : Schedule repair of erosion site prior to the next inspection.					
Inspector Comment					
Runoff erosion on landside slope.

Runoff erosion on landside slope. Fall 2016.

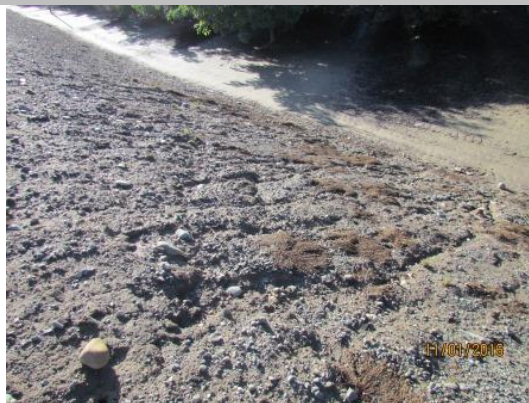
Photo 2 of 3 : SP_2017_RD0537_173_35_20170320_00032.jpg

Runoff erosion on landside slope. Fall 2016.

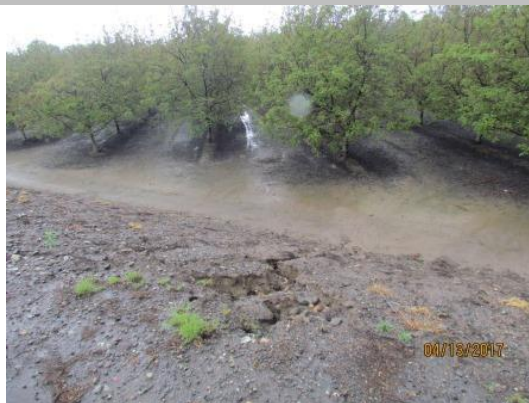
Photo 3 of 3 : SP_2017_RD0537_173_35_20170413_00093.jpg

LM Start	0.81	Rating **	U	Issue No.	35 (cont)	
LM End	0.81	Issue Type +	Ma	Location *	LS	
Category	Earthen Levee			GPS Latitude/Longitude		
				Start		End
Item	Erosion / Bank Caving			38.647181 °		38.647181 °
				-121.571586 °		-121.571586 °
DWR ID	DWR_RD0537_01_f_2016_35					
Comment Code						
E2 : Schedule repair of erosion site prior to the next inspection.						
Inspector Comment						
Runoff erosion on landside slope.

Updated view of runoff erosion on landside levee slope. Erosion has become worse since the last inspection. Spring 2017.

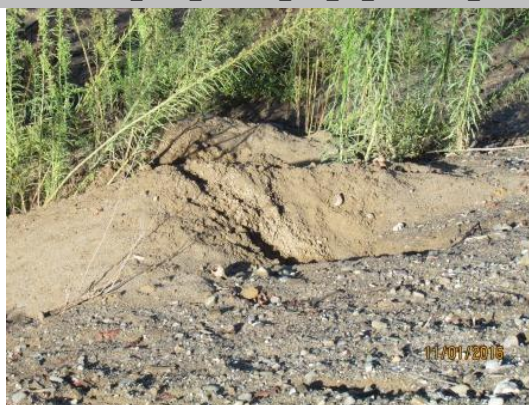
Photo 2 of 2 : SP_2017_RD0537_173_36_20170320_00034.jpg

Close view of a rodent burrow with large amount of soil out. Fall 2016.

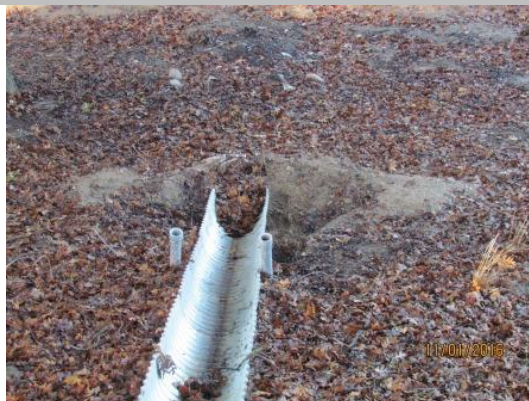
Photo 1 of 1 : SP_2017_RD0537_173_37_20170320_00035.jpg

Rodent burrows with significant amount of soil out the holes located around a drainage pipe. Fall 2016.

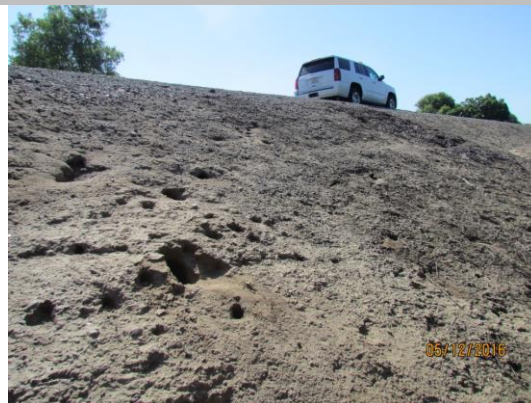
Photo 1 of 1 : SP_2017_RD0537_173_29_20170320_00025.jpg

View of the rodent holes on the landward side of the levee looking downstream. Spring 2016.

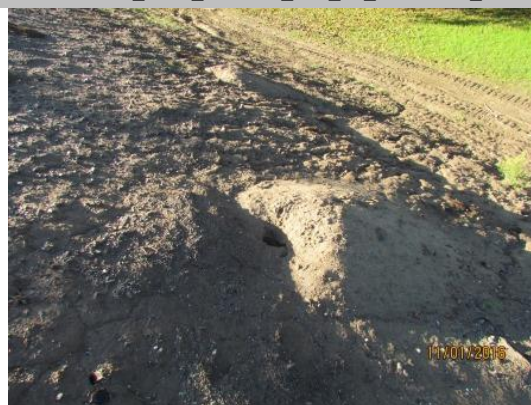
Photo 1 of 1 : SP_2017_RD0537_173_39_20170320_00037.jpg

Animal burrow with more than 2 cu.ft of soil out. Fall 2016.

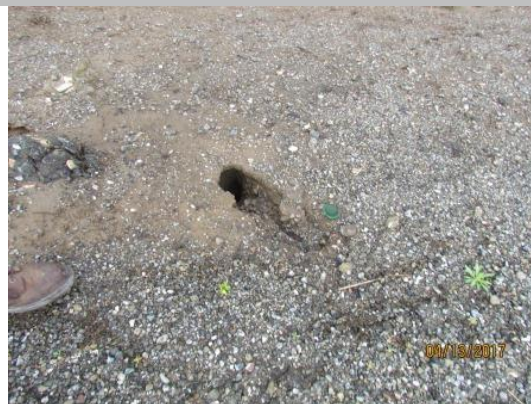
Photo 1 of 1 : SP_2017_RD0537_173_60_20170413_00095.jpg

Large burrow hole on landside levee slope. Spring 2017.

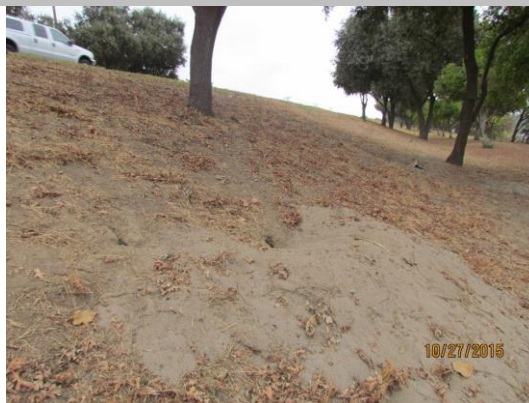
Photo 1 of 3 : SP_2017_RD0537_173_17_20170320_00014.jpg

View of the rodent hole on the waterward side of the levee looking upstream. There are more than 2 cubic feet of material next to the hole. Fall 2015.

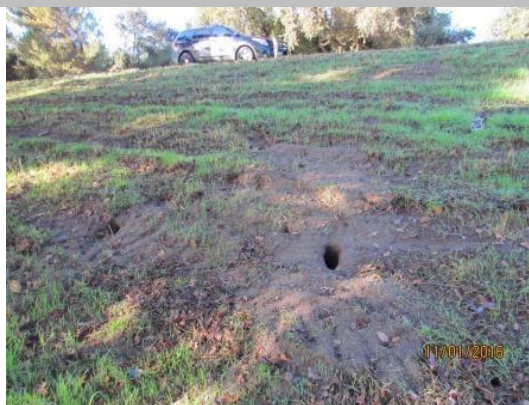
Photo 3 of 3 : SP_2017_RD0537_173_17_20170320_00016.jpg

Updated view of the rodent hole on the waterward side of the levee. Fall 2016.

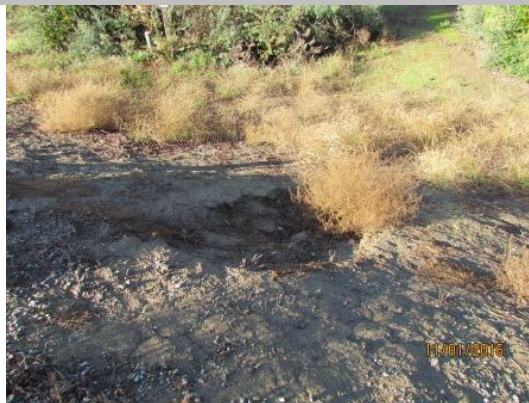
Photo 1 of 1 : SP_2017_RD0537_173_42_20170320_00042.jpg

LM Start	2.67	Rating **	M	Issue No.	42
LM End	2.67	Issue Type +	Ma	Location *	LS
Category	Earthen Levee			GPS Latitude/Longitude	
				Start	End
Item	Erosion / Bank Caving			38.622150 °	38.622150 °
				-121.563441 °	-121.563441 °
DWR ID	DWR_RD0537_01_f_2016_42				
Comment Code					
E2 : Schedule repair of erosion site prior to the next inspection.					
Inspector Comment

View of erosion site on LS slope of the levee. Fall 2016.

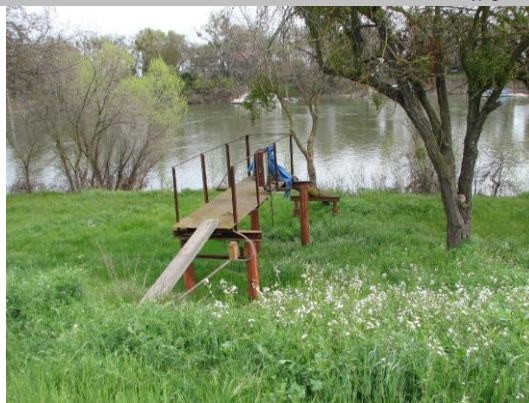
Photo 1 of 3 : UCIP_SP_2017_46035_17008.jpg

LM Start	2.72	Rating **	M	Issue No.	478
LM End	2.72	Issue Type +	En	Location *	LS
Category	Supplemental			GPS Latitude/Longitude	
				Start	End
Item	DWR UCIP Field Study			38.621437 °	38.621437 °
				-121.563373 °	-121.563373 °
DWR ID					
Comment Code					
Inspector Comment					
FS_ID:46035 DS_ID:178 EP_NO: N/A Repair Type: Non-Urgent Crossing Status: Found UCIP Comments: Wasted pipe and valve not visible due to vegetation. FIELD_STRUCT_DESC: 12-inch pipe through the levee, 4.5 feet below the crown. Slant pump column on the waterward bank. Timber walkway (not found) mounted on pile structure across the berm. Siphon breaker in CM pipe riser on the landward slope. Concrete standpipe on the landward side. 6-inch wasted pipe down bank, gate valve on waste line. A 2" electrical conduit through the levee. FS Date: 3/18/2013

WS- overview of pump, pipe and steel structure structure.

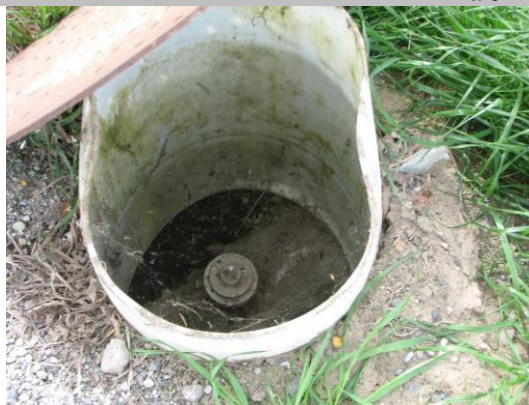
Photo 3 of 3 : UCIP_SP_2017_46035_17006.jpg

LS- siphon breaker in pvc pipe riser.

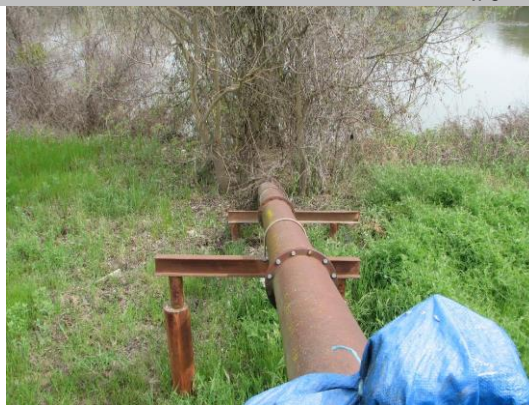
Photo 2 of 3 : UCIP_SP_2017_46037_17026.jpg

LM Start	2.84	Rating **	M	Issue No.	479
LM End	2.84	Issue Type +	En	Location *	LS
Category	Supplemental			GPS Latitude/Longitude	
				Start	End
Item	DWR UCIP Field Study			38.619674 °	38.619674 °
				-121.563330 °	-121.563330 °
DWR ID					
Comment Code					
Inspector Comment					
FS_ID:46037 DS_ID:179 EP_NO: N/A Repair Type: Non-Urgent Crossing Status: Found UCIP Comments: A 6-inch wasted pipe down bank, gate valve on waste line- not visible due to the vegetation. FIELD_STRUCT_DESC: 12-inch pipe through the levee, 7.0 feet below the crown. Slant pump column on the bank. Steel walkway mounted on pile structure across the berm to pump. Burried siphon breaker in CM pipe riser on the landward slope. Concrete standpipe not found on LS but a shallow CM standpipe found on cultivated field. FS Date: 3/18/2013

WS- slanted pump and pipe on steel structure.

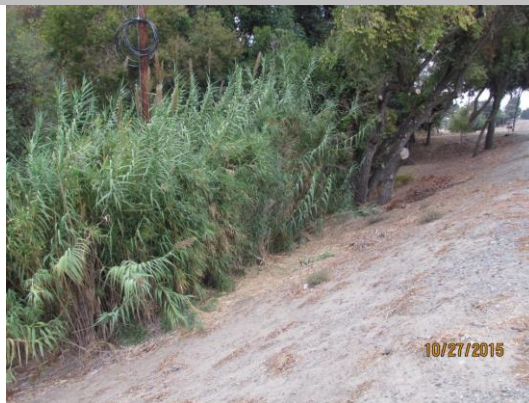
Photo 1 of 1 : SP_2017_RD0537_173_3_20170320_00002.jpg

View of the arundo at the levee toe on the landward side of the levee looking upstream. Fall 2015.

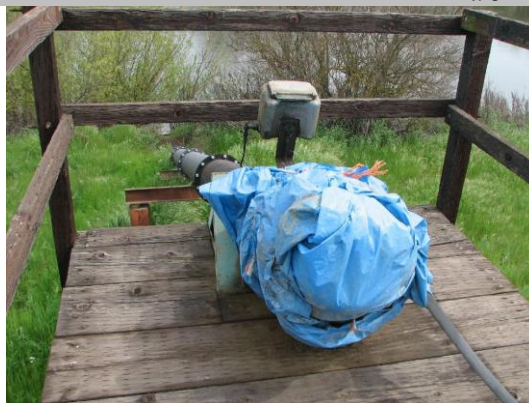
Photo 1 of 3 : UCIP_SP_2017_46806_17038.jpg

WS- slanted pipe and pump on timber structure.

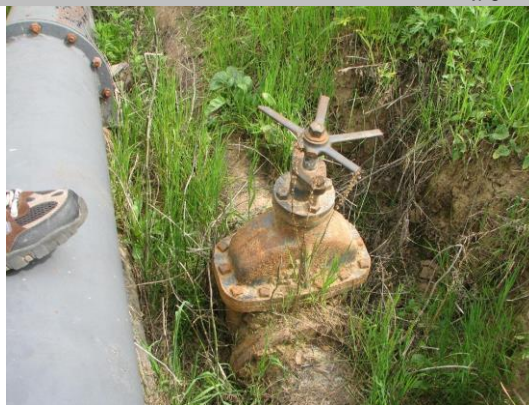
Photo 3 of 3 : UCIP_SP_2017_46806_17036.jpg

WS- main pipe and waste pipe with gate valve

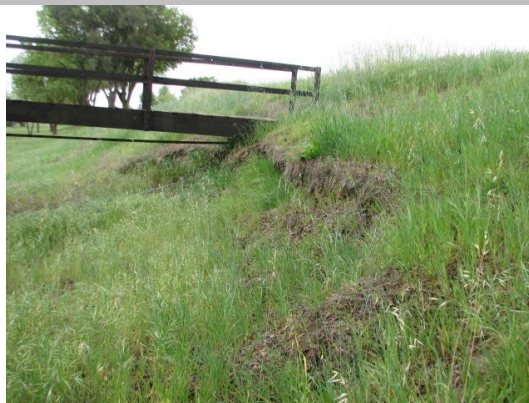
Photo 1 of 4 : SP_2017_RD0537_173_264_20170320_00060.jpg

Erosion cut 20 feet from the other one. Erosion 2-3 feet deep. Spring 2014

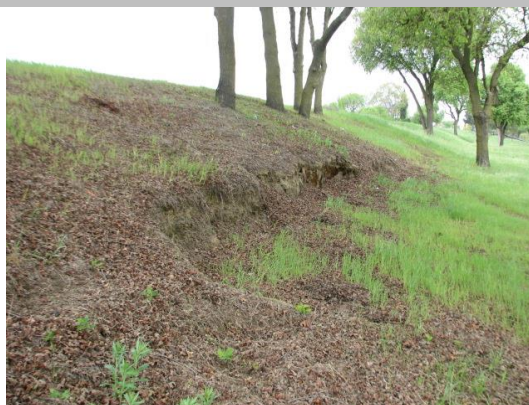
Photo 2 of 4 : SP_2017_RD0537_173_264_20170320_00061.jpg

Erosion cut in levee slope 2-3 feet deep. Spring 2014

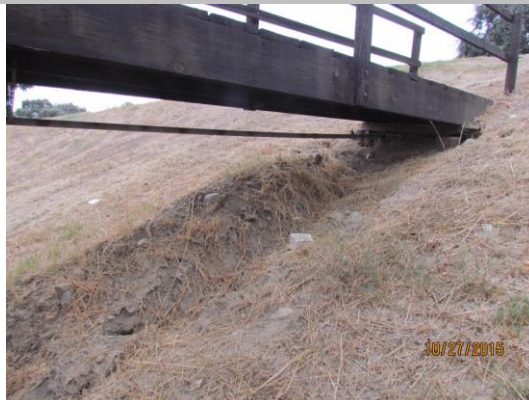
Photo 3 of 4 : SP_2017_RD0537_173_264_20170320_00062.jpg

There is erosion under the gangway on the waterward side of the levee looking downstream. Fall 2015.

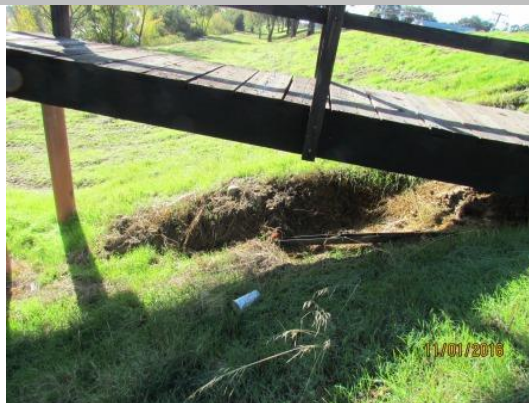
Photo 4 of 4 : SP_2017_RD0537_173_264_20170320_00063.jpg

Updated view of erosion under the gangway that is still present. Fall 2016.

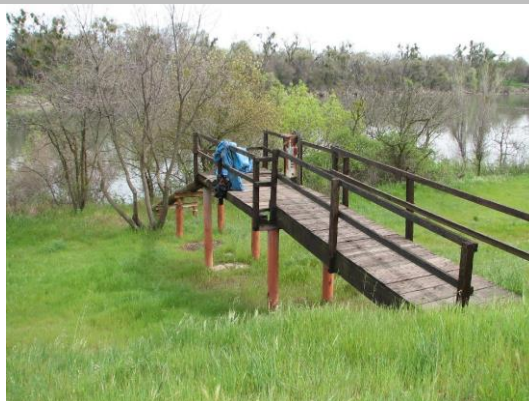
Photo 1 of 3 : UCIP_SP_2017_46041_17171.jpg

WS- overview of slanted pipe and pump on steel pile structure

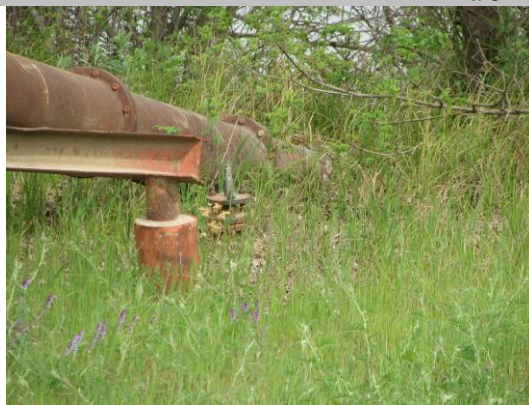
Photo 3 of 3 : UCIP_SP_2017_46041_17169.jpg

WS- slanted pipe and waste pipe gate valve

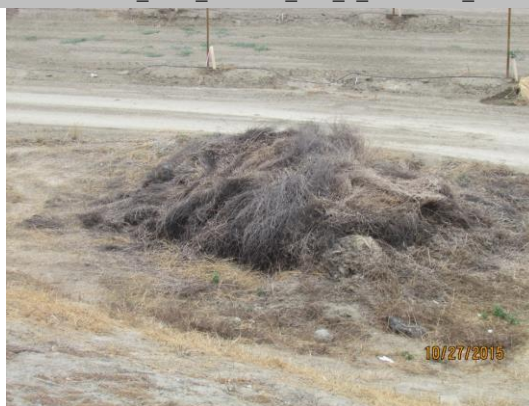
Photo 1 of 1 : SP_2017_RD0537_173_9_20170320_00008.jpg

View of the prunings at the levee toe on the landward side of the levee. Fall 2015.

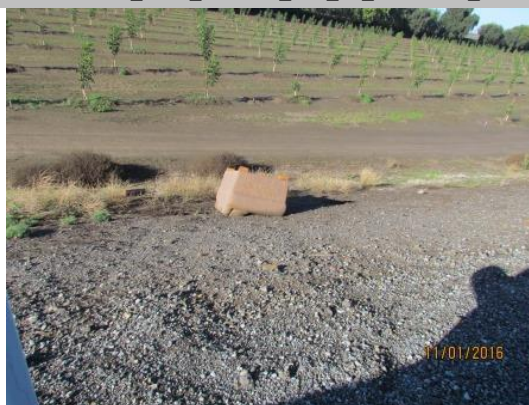
Photo 1 of 1 : SP_2017_RD0537_173_43_20170320_00043.jpg

Garbage on LS slope. Fall 2016.

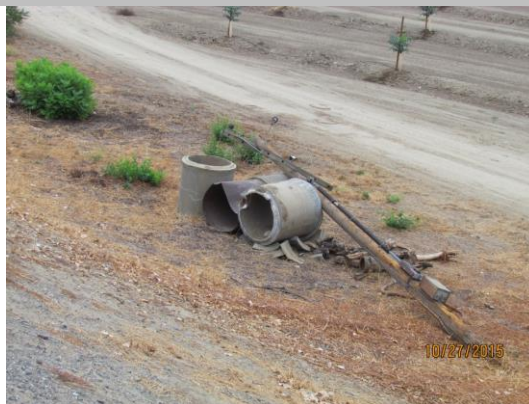
Photo 1 of 1 : SP_2017_RD0537_173_14_20170320_00009.jpg

View of concrete debris and a utility pole on the landward side of the levee. Fall 2015.

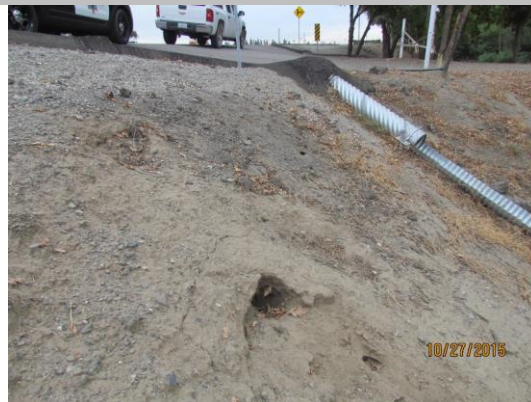
Photo 1 of 4 : SP_2017_RD0537_173_15_20170320_00010.jpg

View of the rodent hole on the landward side of the levee looking downstream. Fall 2015.

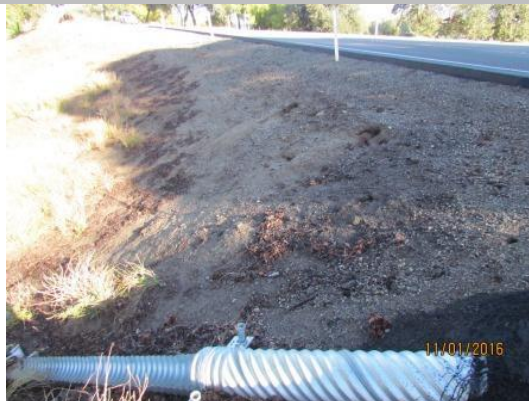
Photo 4 of 4 : SP_2017_RD0537_173_15_20170320_00013.jpg

Number of rodent holes on landside slope of the levee. Fall 2016.

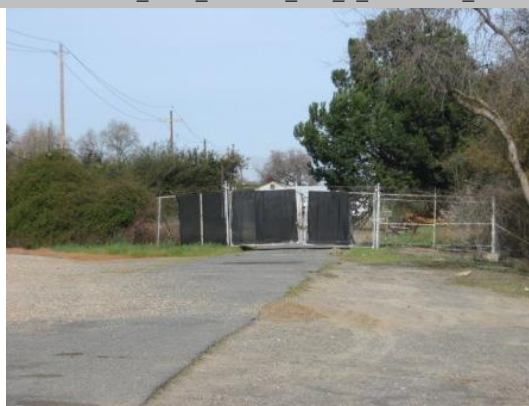
Photo 1 of 2 : SP_2017_RD0537_173_8_20170320_00006.jpg

Abandoned building and fence on the levee crown. Spring 2013

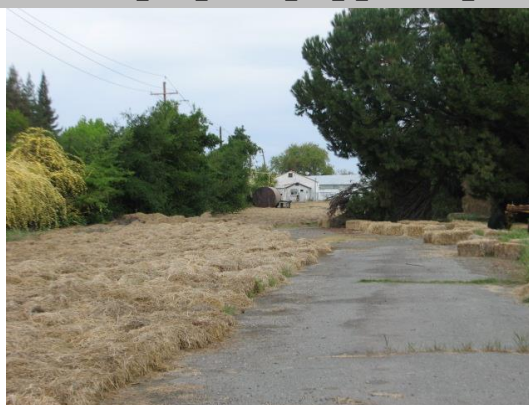
Photo 2 of 2 : SP_2017_RD0537_173_8_20170320_00007.jpg

Building and old equipment within the fenced compound. Spring 2014

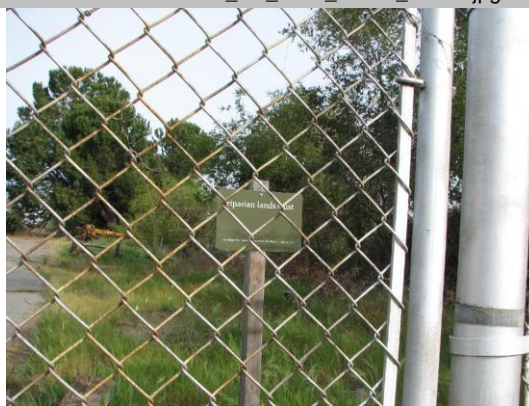
Photo 1 of 3 : UCIP_SP_2017_45026_17073.jpg

Riparian Lands Trust- no access through gate.

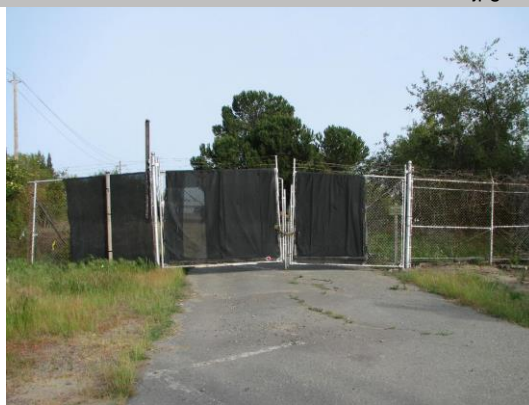
Photo 2 of 3 : UCIP_SP_2017_45026_17072.jpg

No access through gate. Area behind gated area along WS slope accessible.

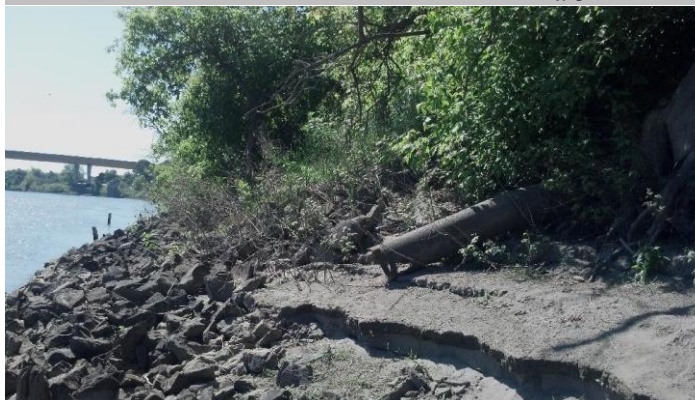
Photo 3 of 3 : UCIP_SP_2017_45026_74045.jpg

12" pipe along WS slope resting on possible remnant of pump house.

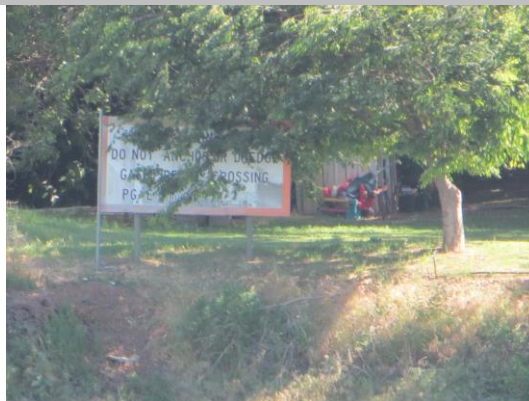
Photo 2 of 3 : UCIP_SP_2017_45024_74021.jpg

Closeup of PGE "Gas Pipeline Crossing" sign on opposite bank.

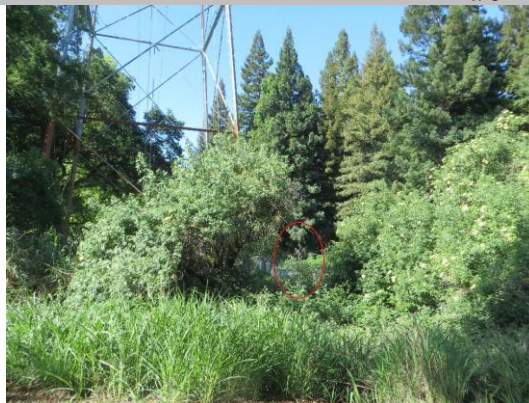
Photo 3 of 3 : UCIP_SP_2017_45024_74040.jpg

Marker off LS toe at base of tower at opposite side of RR tracks.

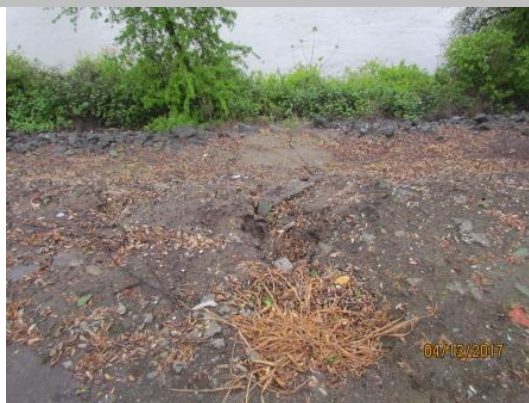
Photo 1 of 2 : SP_2017_RD0537_173_56_20170413_00090.jpg

View of first erosion location on waterside levee slope. Spring 2017.

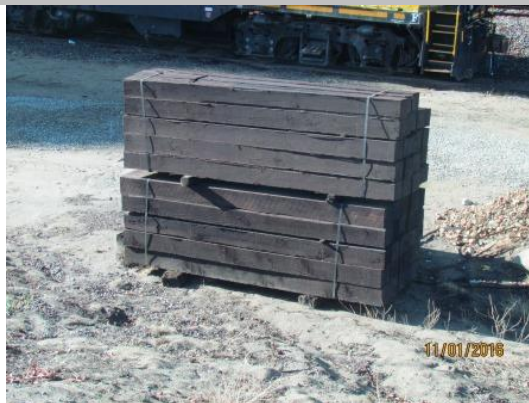
Photo 1 of 1 : SP_2017_RD0537_173_46_20170320_00046.jpg

Stock of RR rail ties at levee toe on landward side. Fall 2016.

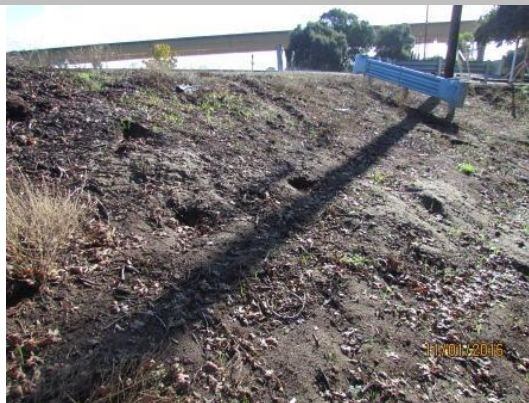
Photo 1 of 2 : SP_2017_RD0537_173_475_20170320_00064.jpg

Updated view of rodent holes on LS slope. More holes appeared. Fall 2016.

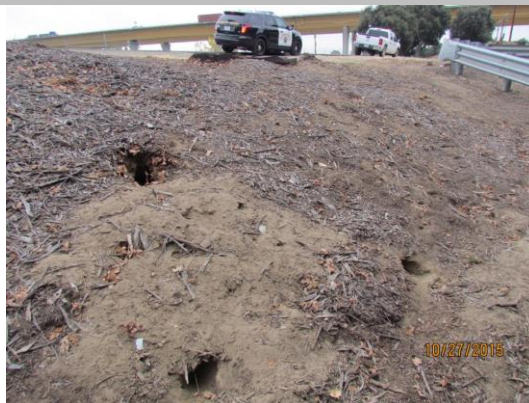
Photo 2 of 2 : SP_2017_RD0537_173_475_20170320_00065.jpg

View of the rodent hole on the landward side of the levee looking downstream. Fall 2015.

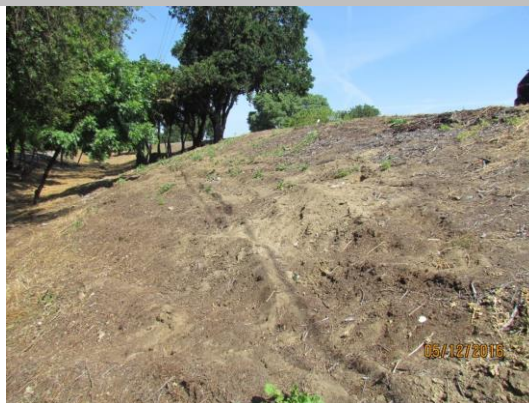
Photo 1 of 1 : SP_2017_RD0537_173_30_20170320_00026.jpg

View of the slope stability caused by vehicles on the waterward side of the levee looking downstream. Spring 2016.

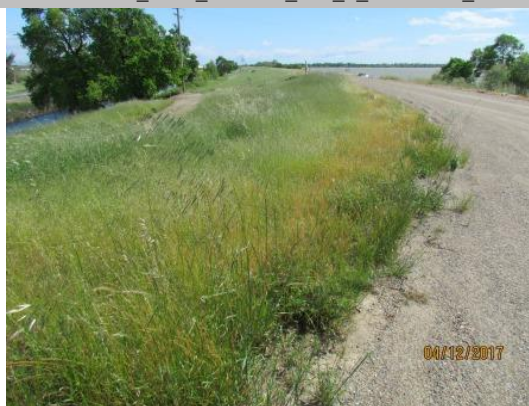
Photo 1 of 1 : SP_2017_RD0537_174_1_20170413_00005.jpg

Tall grass on landside levee slope, blocking visibility. Spring 2017.

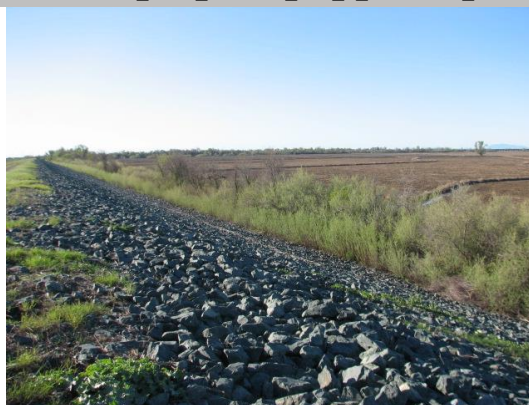
Photo 1 of 2 : SP_2017_RD0537_174_4_20170320_00003.jpg

Photo of the willows at the toe of the rip rap and levee. No other trees in the rip rap. Spring 2014

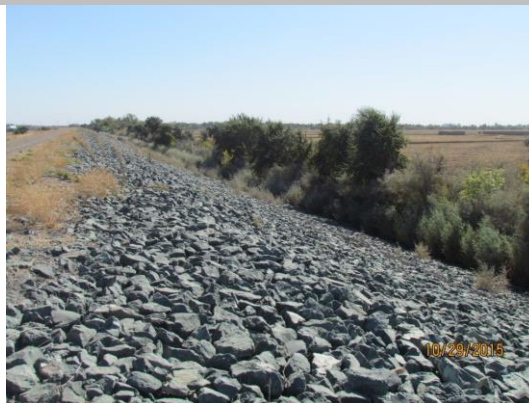
Photo 2 of 2 : SP_2017_RD0537_174_4_20170320_00004.jpg

View of the willows at the toe of the waterward side of the levee looking upstream. Fall 2015.

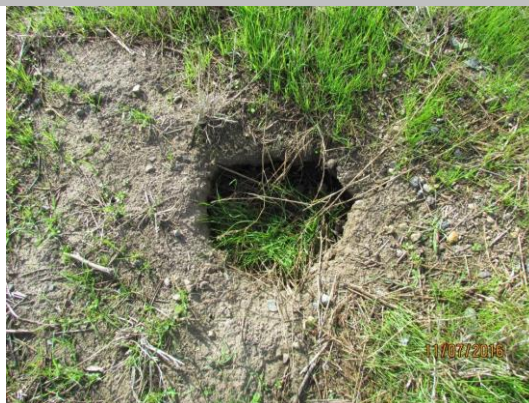
Photo 1 of 2 : SP_2017_RD0537_174_2_20170320_00001.jpg

Pothole on LS slope near levee crown. Fall 2016.

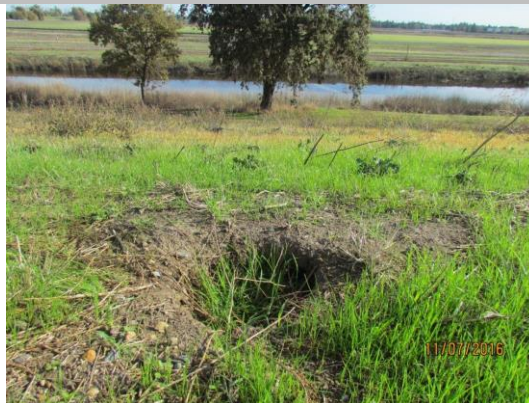
Photo 2 of 2 : SP_2017_RD0537_174_2_20170320_00002.jpg

Perspective view of a pothole on LS slope near levee crown. Fall 2016.
